INDOOR AIR QUALITY ASSESSMENT

**Ralph B. O'Maley Middle School Gymnasium
32 Cherry Street
Gloucester, Massachusetts**

Prepared by:
Massachusetts Department of Public Health
Bureau of Environmental Health Assessment
August 2002

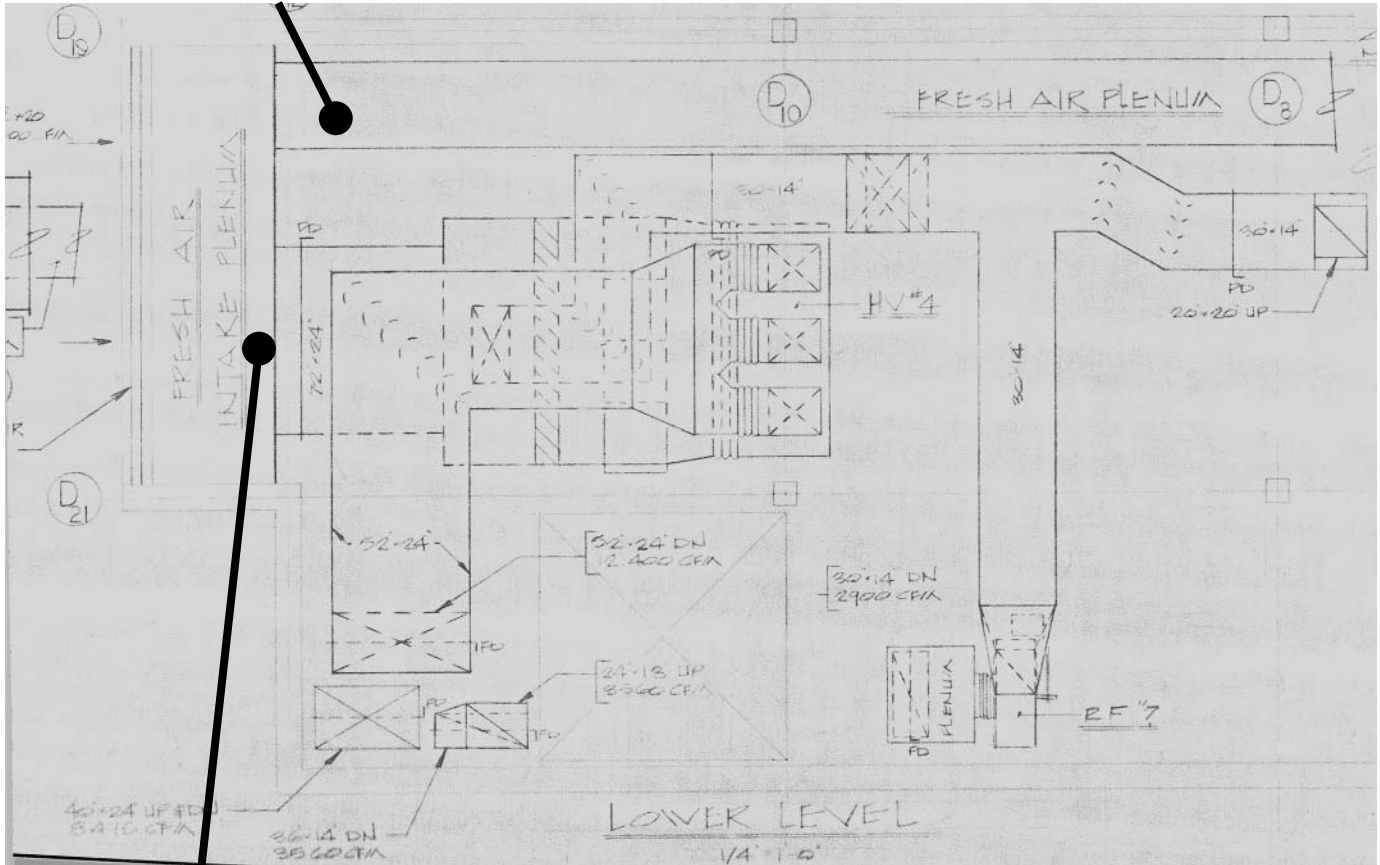
Blueprint 4
Fresh Air Intake Plenum, Mechanical Room 2

- Both HV4 (the shop AHU) and HV2 (the gym AHU) share a common fresh air plenum (see Blueprints 4 and 5). According to the blueprint, the draw of air by the HV2 was originally

HV2 Fresh Air Intake

HV4 Fresh Air Intake

Return Vent Connected to HV4

7. Examine the feasibility of separating the fresh air intake for HV2 and HV4. Remove plywood sheet within the fresh air intake plenum (see Picture 2) to decrease pooling air.

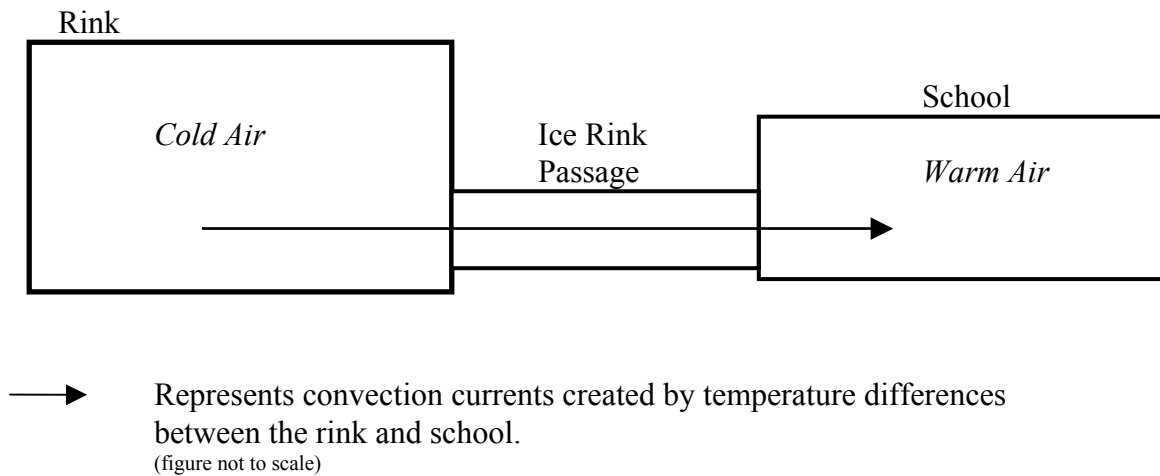
Figure 1

The refrigerated air of the ice rink, in combination with heated air of the school and gymnasium creates convection currents. These currents move from the rink into the gymnasium through a connecting hallway and into the front hall of the school (see Figure 1).

**Convection Currents From the Talbot Rink to the O'Maley Middle School via the
Ice Rink Passage**

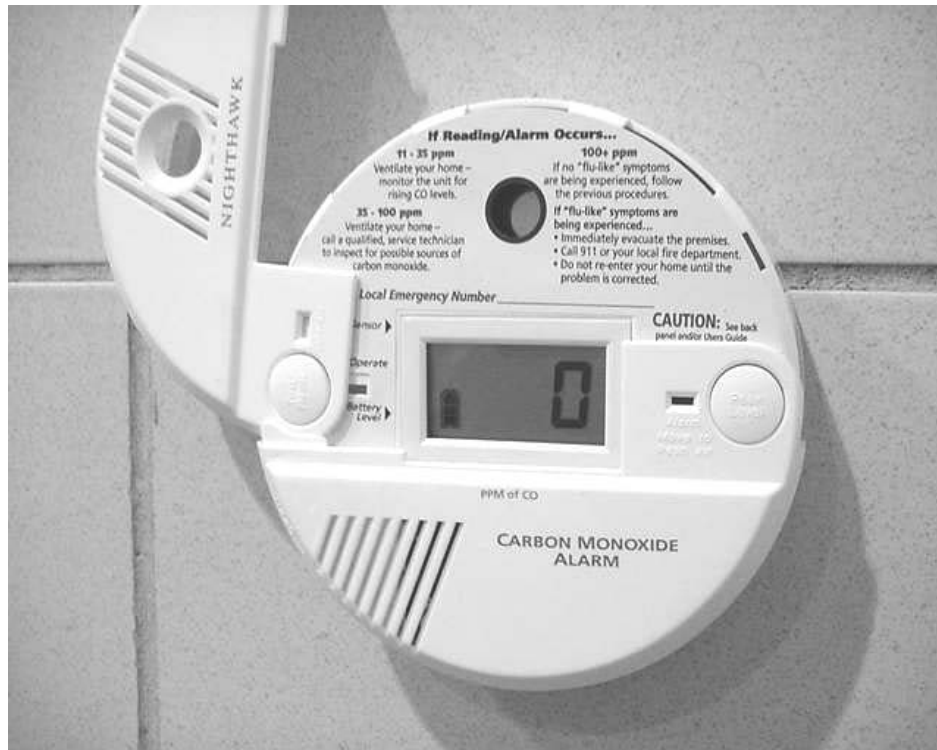
Picture 1

Based on information concerning symptoms of building occupants described by GPS officials (headache, nausea, lethargy, and tiredness), BEHA staff suggested that digital readout carbon monoxide (CO) detectors (see Picture 1) be installed and allowed to operate for several days prior to the visit described in this report.

CO Monitor Installed In Gymnasium

1. Continue to use wall-mounted alarms to monitor CO concentrations in the gymnasium and boiler room. CO levels should be checked daily after the boiler is fired up during the heating season.

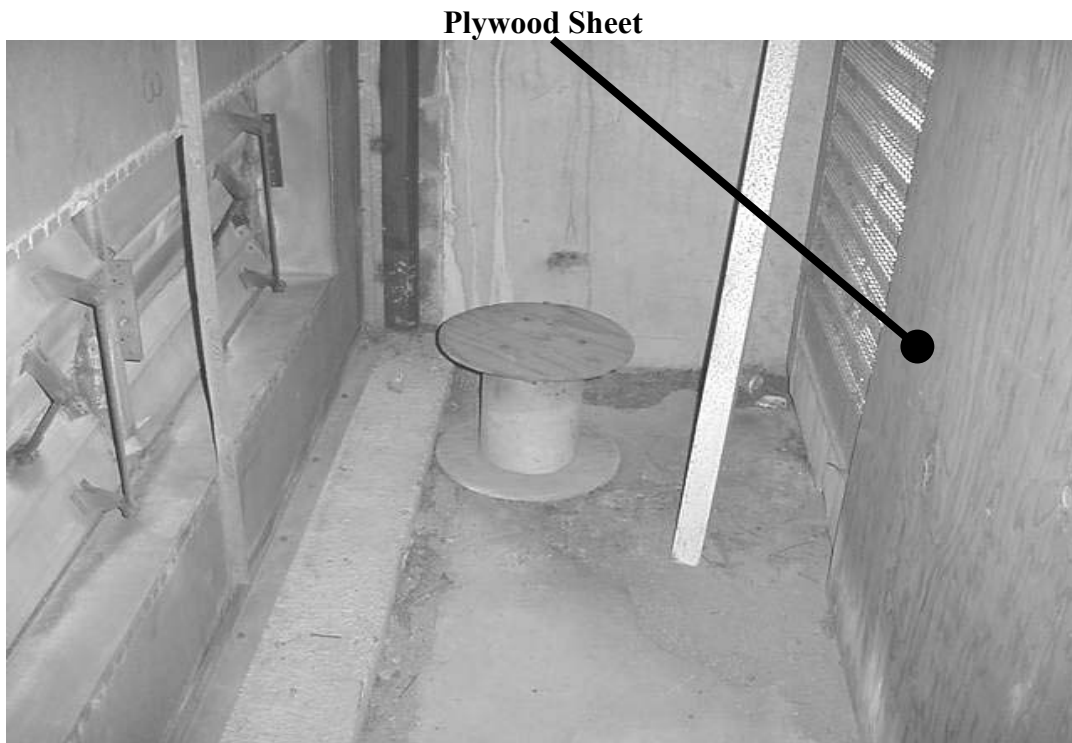
Picture 2A

All areas surveyed by BEHA staff within the building were sampled for CO. No detectable levels of CO were measured in any area of the building, including the main office, gymnasium, locker rooms, art room, hallway to the ice rink, gymnasium mechanical room and the fresh air intake chamber (see Picture 2) of the vent located above the entrance to the gymnasium.

Interior Of Gymnasium Fresh Air Intake (Mechanical Room 2)

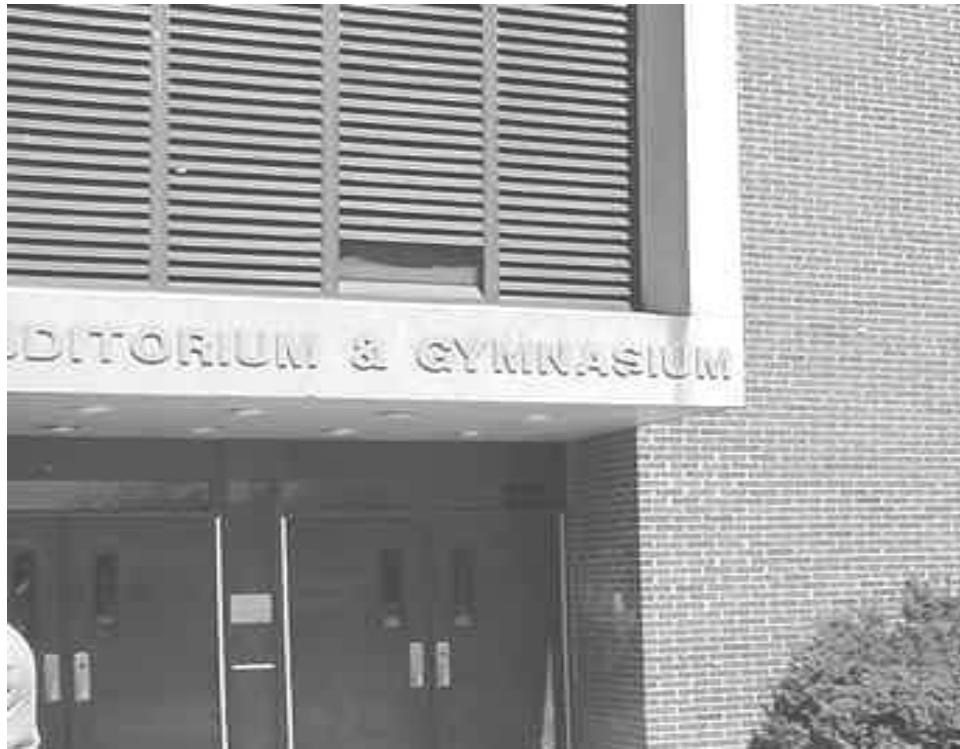
Picture 2B

Exterior of Gymnasium Fresh Air Intake

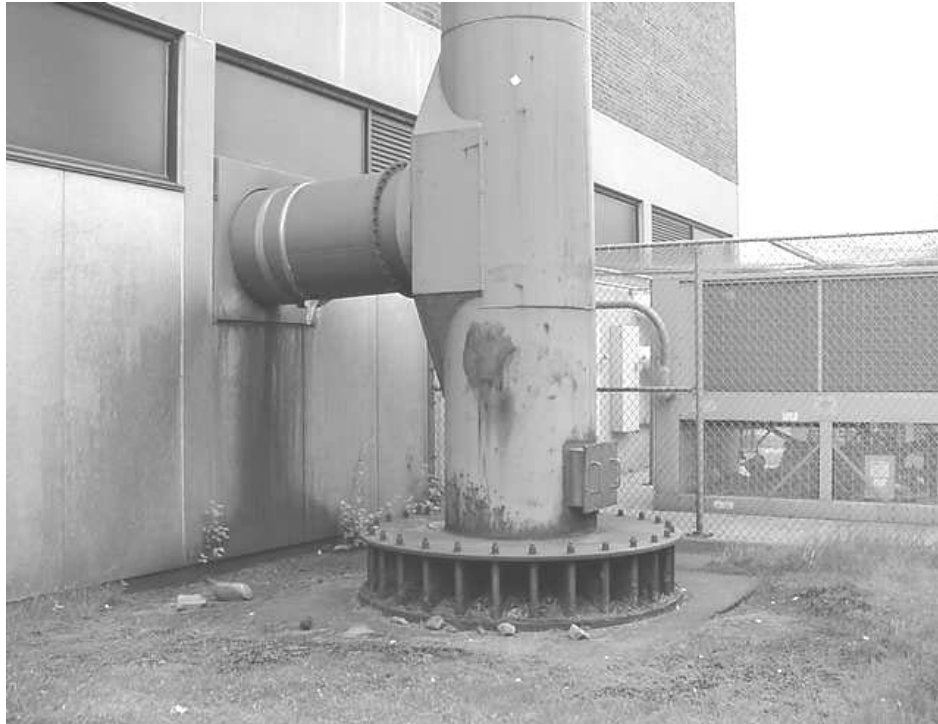
Picture 3

BEHA staff believes that the primary source of CO is the exhaust vent/chimney for the boiler (see Picture 3). Of note is a duct that transverses the boiler room/pottery room interior wall. Located in close proximity to the boiler room/pottery room duct junction is a return vent for HV4, the air handling unit (AHU) that services the shops (see Blueprints 1 and 2). Significant spaces existed between the duct and the wall and the boiler room/pottery room duct junction (see Picture 4), which may allow for air to move from the boiler room into the ceiling space (called a plenum). The presence of a return vent can create a localized depressurization of the ceiling plenum, which can then serve to draw boiler room air.

Exhaust Vent/Chimney for the Boiler

2. Continue with plans to repair the chimney/boiler exhausts vent.
3. Seal outdoor penetrations in the boiler exhaust vent pipe.
4. Seal holes in the common wall between the boiler room and classrooms.

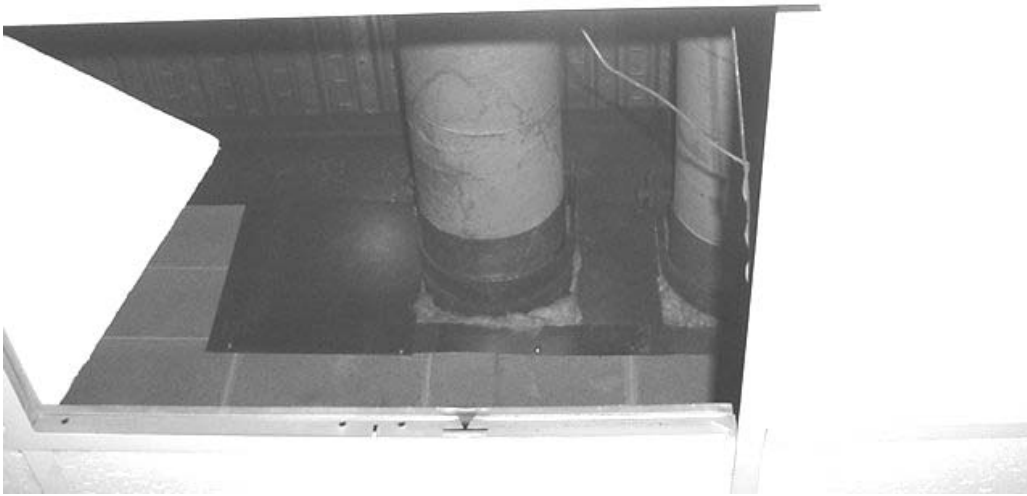
Significant Spaces Existed Between the Duct and The Wall and The Boiler Room/Pottery Room Duct Junction, Now Sealed With Fiberglass

10. Render the wall shown in Picture 4 airtight.

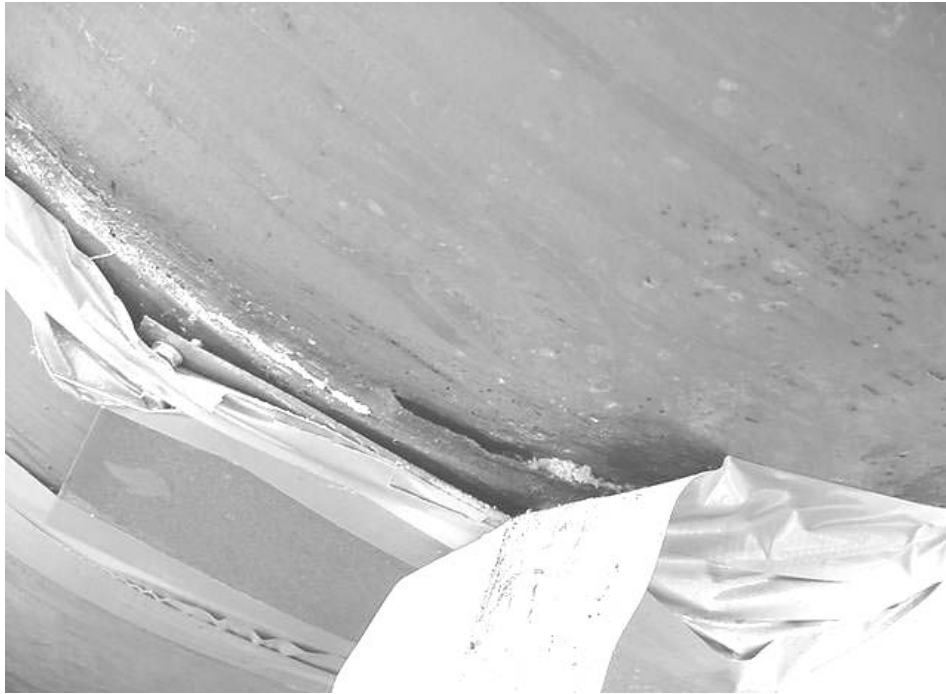
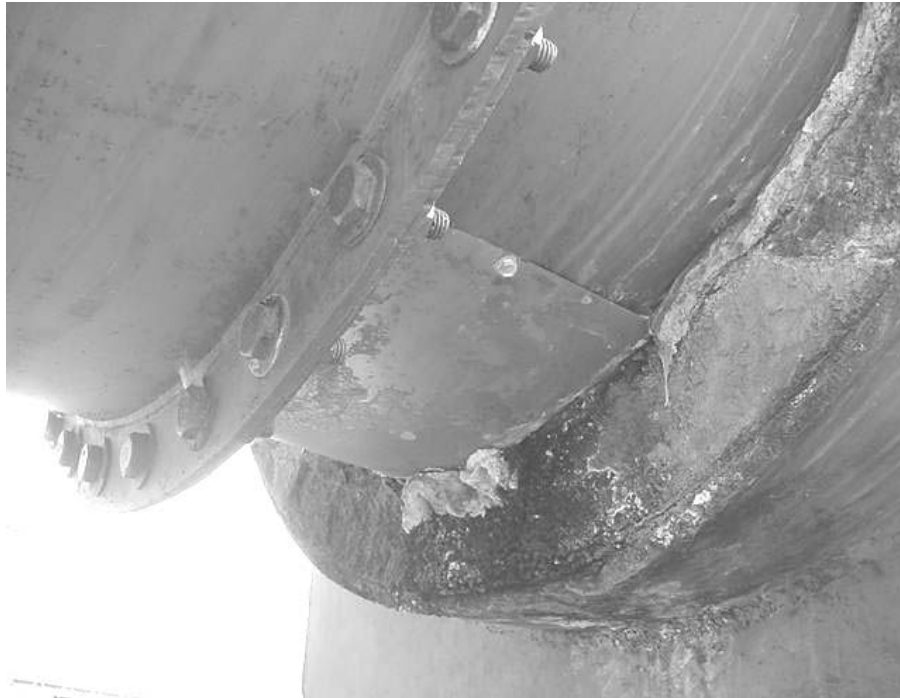
The vent connecting the chimney to the boiler has developed several holes, which have the potential to release CO (see Pictures 5 and 6). The metal plate through which the exhaust vent passes has buckled, resulting in the exhaust vent dropping downward (see Pictures 7 and 8). The movement of the exhaust vent has created spaces in the exterior wall for outdoor air to penetrate into the boiler room. Since cold air moves to hot air, it is expected that cold outdoor air during the winter would move through these spaces to the warmer boiler room. Pollutants released into this air (e.g., leaks from the boiler) could then be drawn into the boiler room. The boiler room/pottery room duct junction and the chimney exhaust vent/exterior wall junction are in close proximity, which may serve as a direct pathway for CO to migrate from the boiler room into the return vent in the pottery room and to HV4 in Mechanical Room 2.

Holes In Boiler Exhaust Vent

Holes in Boiler Exhaust Vent

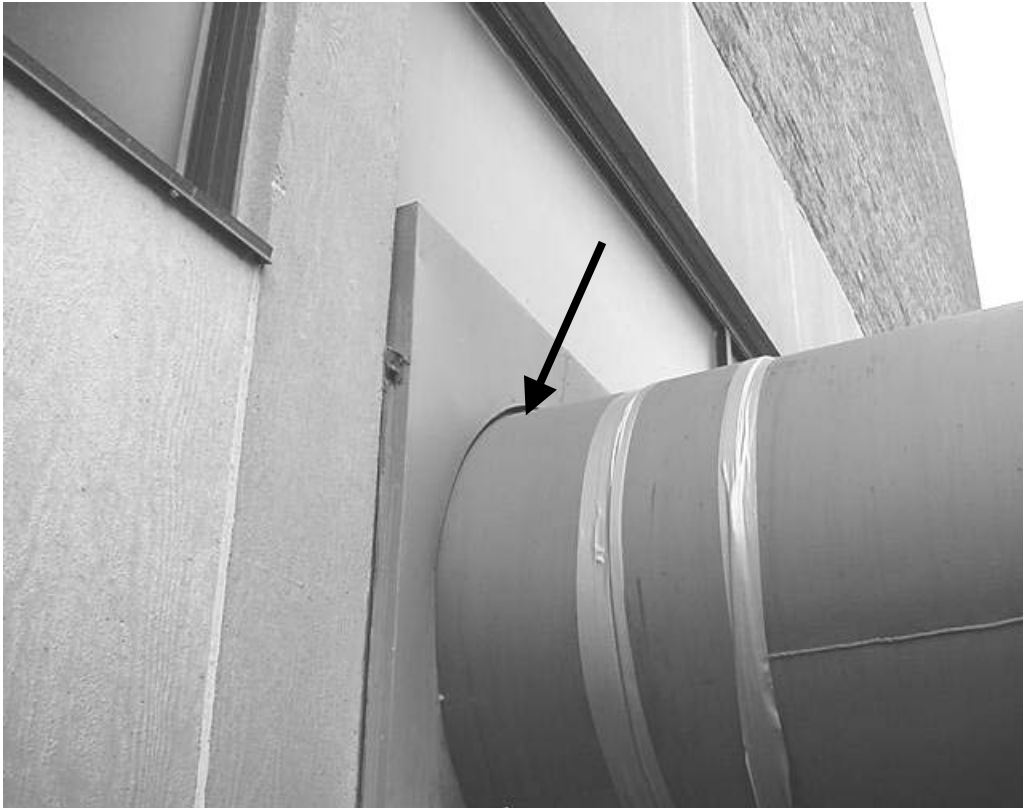
Picture 7

Space Around Exhaust Vent, Exterior View

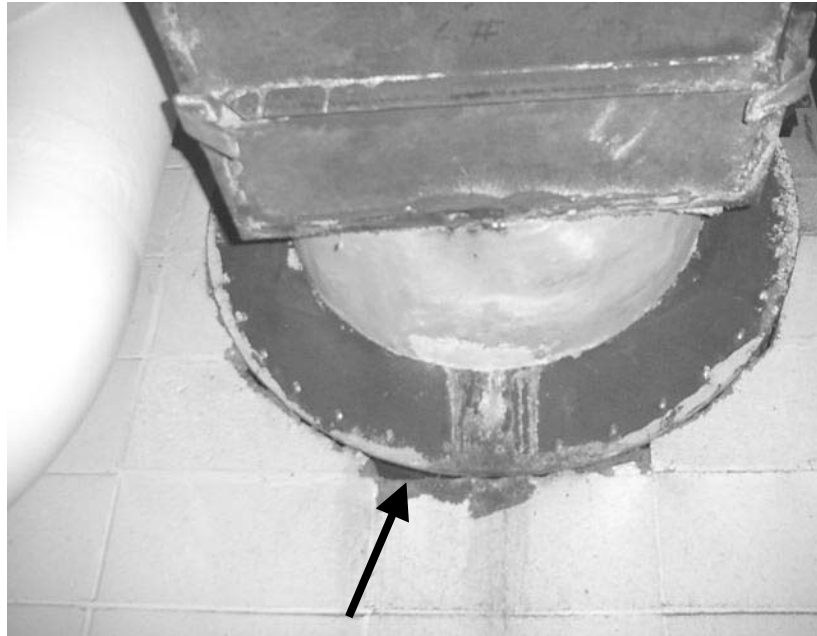
Picture 8

Space Around Exhaust Vent, Boiler Room Interior View

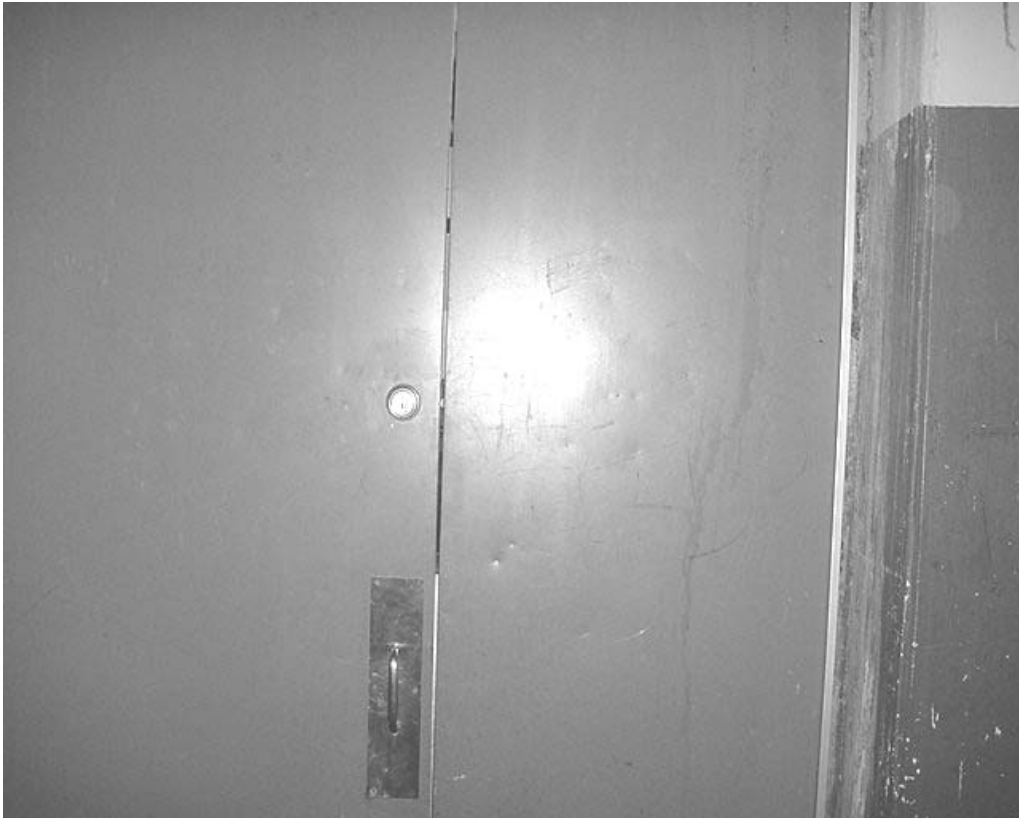
Picture 9

- Air spaces exist in the ice rink door (see Picture 9). A draft of cold air was detected moving from the colder ice rink into the warmer ice rink passageway. Light from the rink can be seen in and around doors and light from the rink can be seen through the electrical box in the cinder block wall.

Space In Ice Rink Access Door

8. Render the Talbot Rink access door from the ice rink passage as airtight as feasible.
Remediation steps should include:
 - installing weather stripping on the doorframes;

- installing a door sweep at the bottom of the ice rink door; and
 - sealing the door frame/wall junction with an appropriate sealing compound.
9. The doors separating the ice rink passage from the school should be reinstalled. All doors should be remediated in the manner listed in recommendation #8.

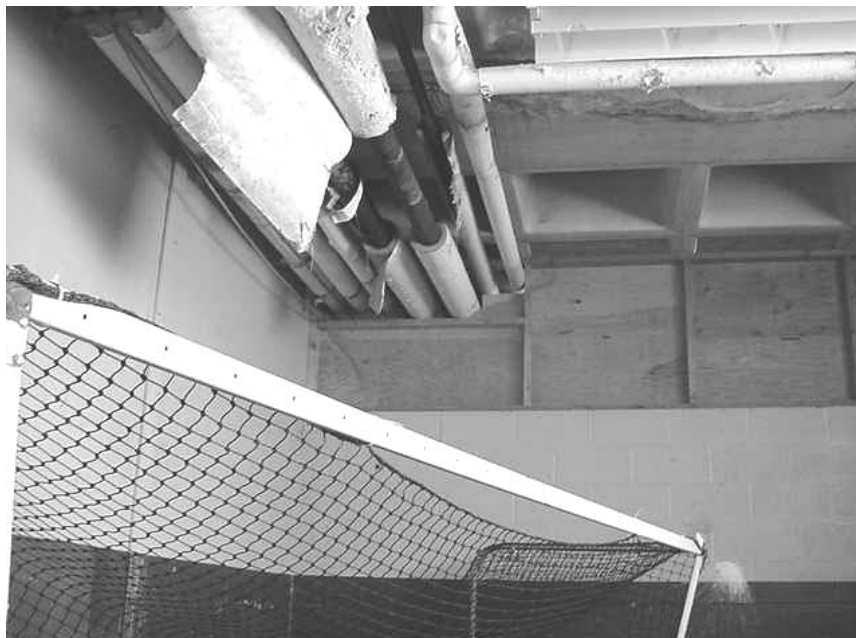
Picture 10

- A large wooden wall was observed above the ice rink passageway (see Picture 10). Utility pipes pass through this wooden wall. If connected to the rink, it may be a pathway for rink air to migrate into the ice rink passageway.
- The doors separating the ice rink passageway from the school were missing (see Picture 11), which can allow for ice rink air to penetrate into the school.

Large Wooden Wall and Utility Pipes in Ice Rink Passageway

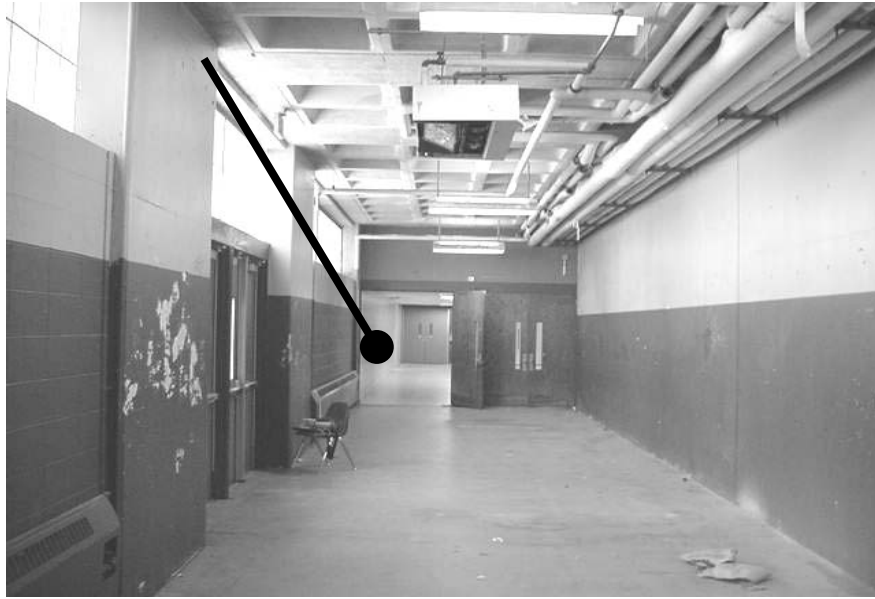
Picture 11

Missing Door Separating the Ice Rink Passageway Doors from the School
